INDUSTRIAL CASE STUDY

RAF VALLEY.

Project Name	RAF Valley – Fixed Wing and Rotary Buildings
Client	Kier Construction Northern
Service	Redecoration to Aircraft Hangars and Support Offices
Length of Contract	4 months

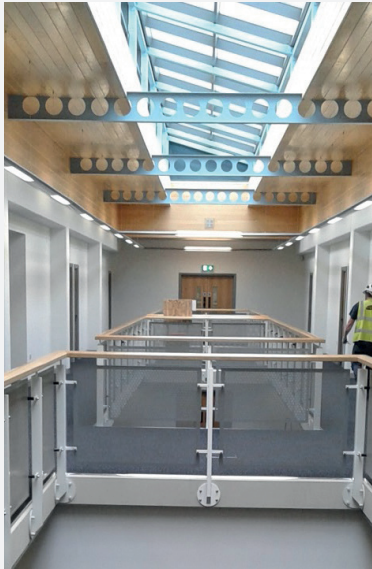
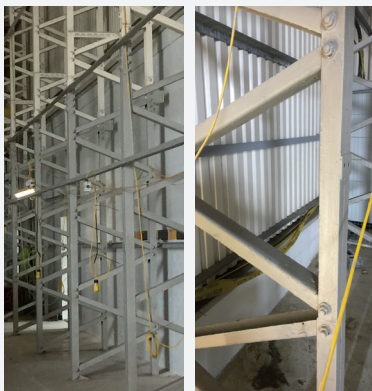
The existing paint on the steelwork in the hangar was identified as containing lead so needed to be carefully stripped back to metal prior to the new paint system being applied.

We used a low-VOC paint removal method which involved a chemical paste which did not give off fumes. The resulting material produced was easy to control and was removed from site by a specialist waste disposal company.

We then applied a protective aluminium primer, hi-build epoxy undercoat followed by 2-pack gloss top coats.
