INDUSTRIAL CASE STUDY

CROWN PACKAGING, CARLISLE.

Project Summary

Project Name	Crown Packaging, Botcherby Carlisle
Client	Crown Packaging / Crown Bevcan (UK) PLC
Service	Floor Repair and Epoxy Coating, General Painting

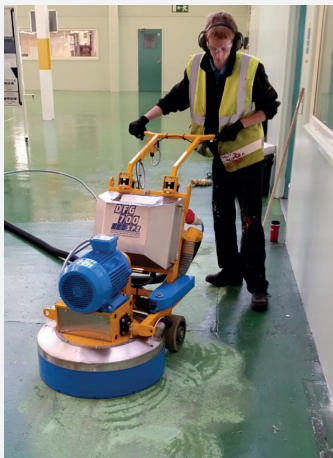
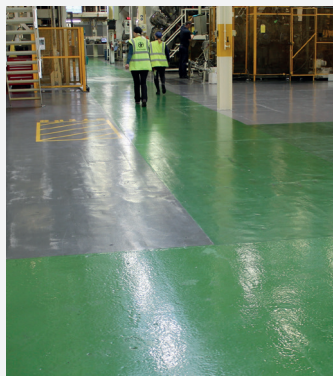
We used a 3-headed diamond grinder to prepare the surface back to concrete, with continuous vacuum-controlled dust extraction to reduce external contamination. When required, rubberised floor areas are also scabbled prior to grinding.

Floor damage is repaired where necessary using epoxy mortar, and concrete sealant applied with a roller.

Heavy-duty epoxy paint is applied using hand float and rollers to provide a seamless hard-wearing, chemical-resistant finish suitable for high-volume traffic. Safety markings and bay labels are applied as per specification by the client, using stencils where appropriate. Products used are solvent-free and low-odour. Flooring materials used are supplied by Resin Surfaces Limited.
